# HOME INSPECTION REPORT

## SAMPLE REPORT

**Inspection Date:**  
February 13, 2009

**Report Number:**  
0000000-021309

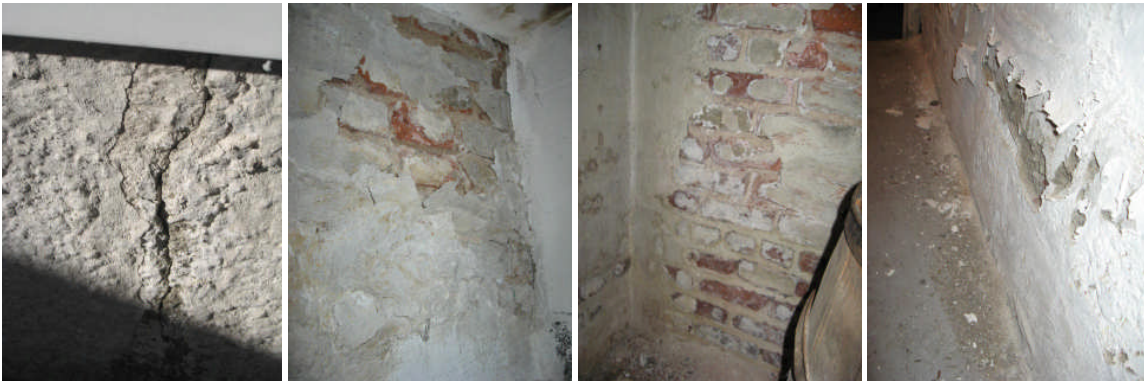
- **Monitor:** Minor vertical cracking was observed in the foundation. This type of cracking is usually the result of shrinkage of the concrete as it cures. Shrinkage cracks are very common and should not be cause for alarm. This area should, of course, be monitored. The rate of movement cannot be predicted during a one-time inspection.
- **Improve:** Surface deterioration was observed on the interior of the exposed foundation walls. This condition is common in many older homes and does not usually represent a serious structural concern. In an effort to prevent long-term deterioration, it would be wise to consider re pointing (replacement of the mortar between the bricks) and parging-deteriorated areas. Lot drainage improvements, as outlined in the “Exterior” section of this report are also recommended.

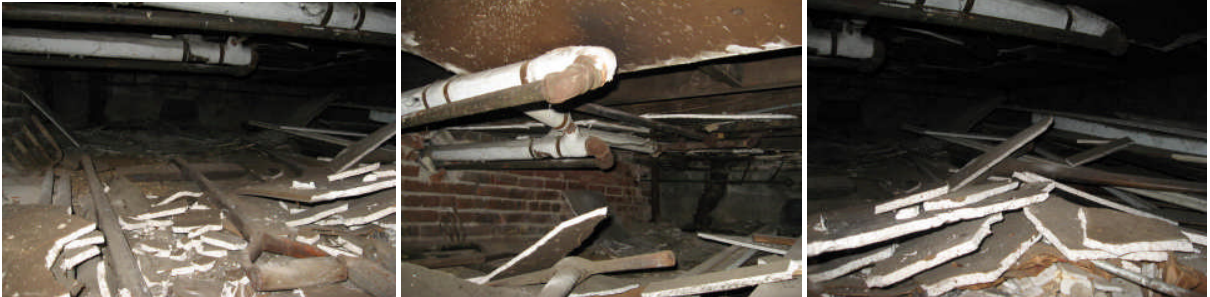
- **Improve:** All wood debris and/or trash should be removed from the crawl space.
- **Improve:** Crawl space wood/soil contact should be eliminated. This condition is conducive to rot and wood boring insect activity.
- **Improve:** There is evidence of vermin activity in the crawl space. A pest control specialist should be consulted in this regard.

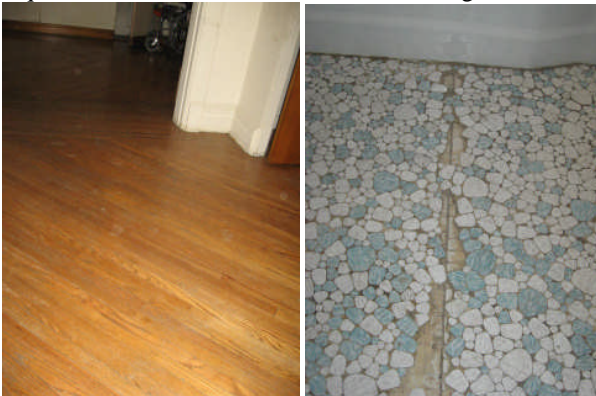
- **Monitor:** The floor structure has experienced some typical sagging and movement. This is usually the result of the age and framing design of the building. This condition is very typical in older homes. While improvements could be undertaken, they are not considered necessary at this time.
- **Improve:** Evidence of loose flooring and tile was detected adjacent to the toilet and bathtub enclosure in the first floor bathrooms. The extent of damage is difficult to predict without removing floor coverings. Further investigation is required to determine the extent of the damage and the needed repairs.

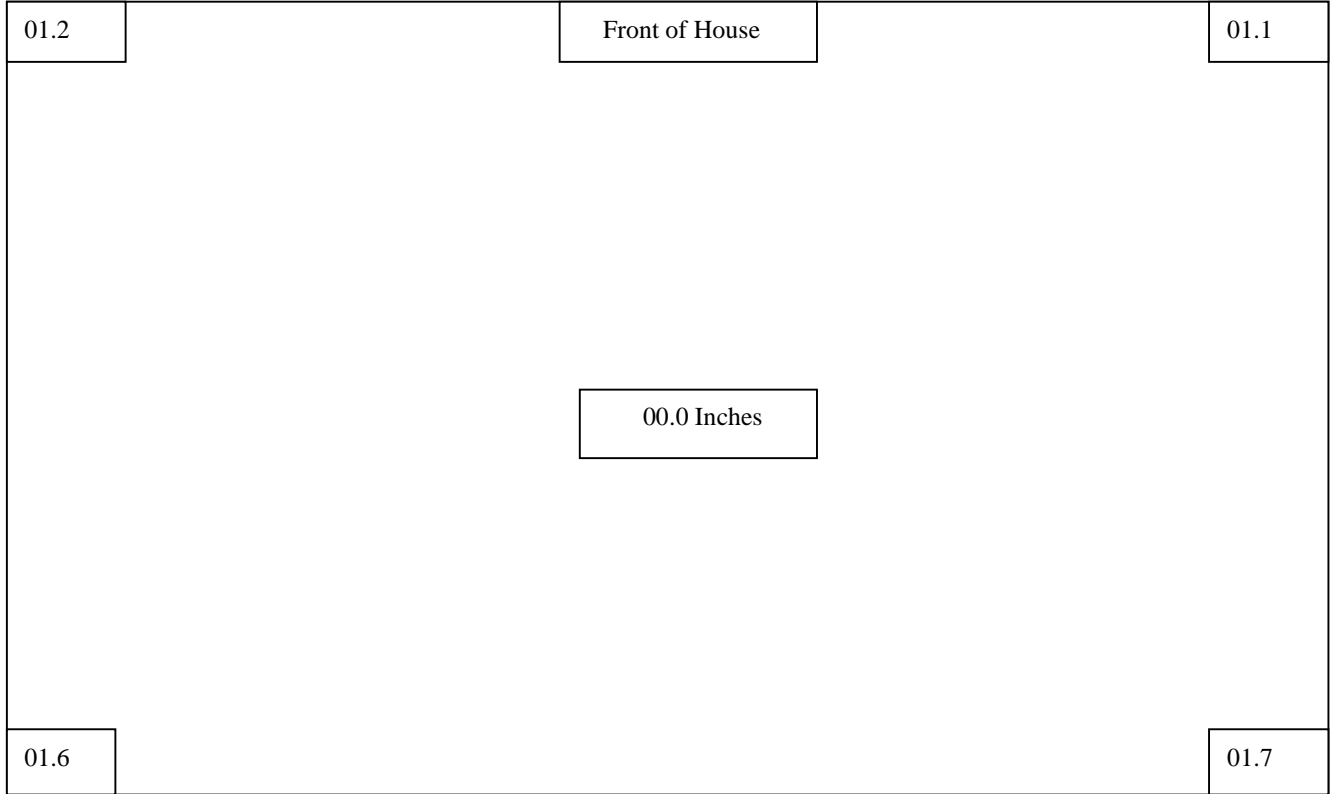
An elevation differential of 02.9 Inches was recorded between the highest and lowest point in the foundation of the house. The house is the lowest at the rear (01.6 – 01.7 Inches) and at the front (001.2 Inches)

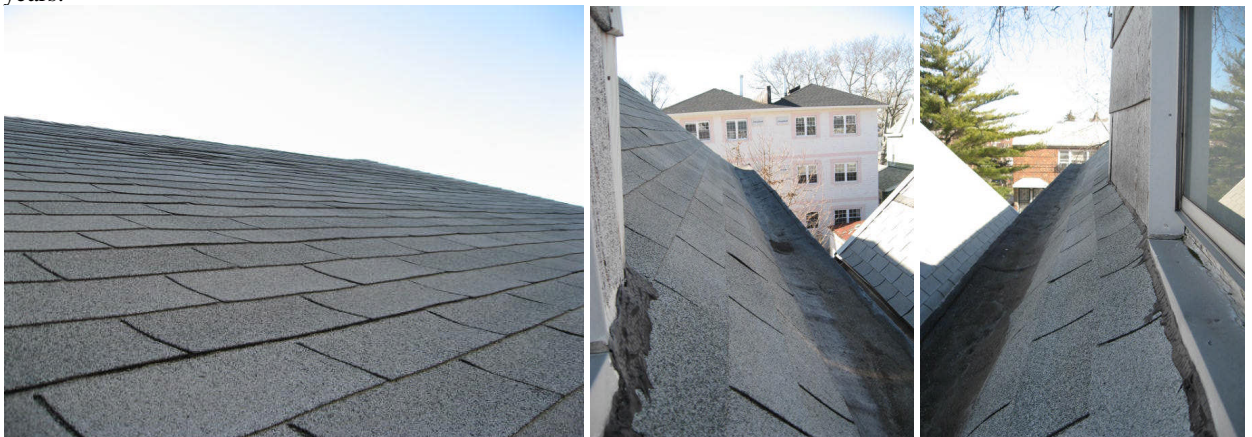
**Improve:** The roofing on the main roof is considered to be in fair condition. Minor repairs are recommended in the short term to maintain the weather tightness of the roof. Damaged or missing roofing material should be repaired. All roof penetrations should be examined and sealed as necessary. Replacement should be anticipated within the next four years.

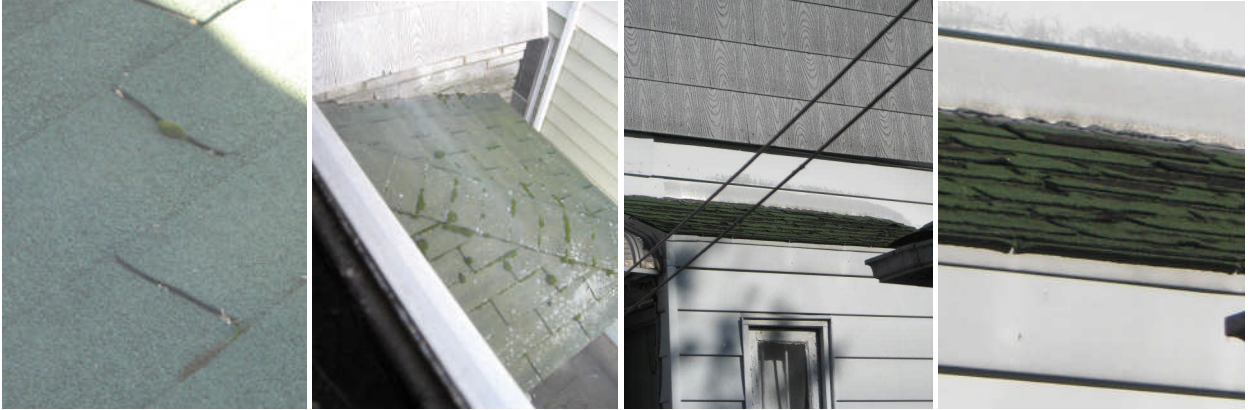
- **Monitor:** The roofing at the front slopes shows evidence of moss and organic build up in heavily shaded areas. This condition may influence the life expectancy of the roofing. Minor repairs are recommended in the short term to maintain the weather tightness of the roof. Damaged or missing roofing material should be repaired. All roof penetrations should be examined and sealed as necessary. Replacement should be anticipated with in the next two years.
- **Major Concern:** The roofing on the addition should be replaced. The roof shingles have curled edges, signifying they are at the end of their useful life cycle. New shingles should not be installed over a roof that has these curled edges.

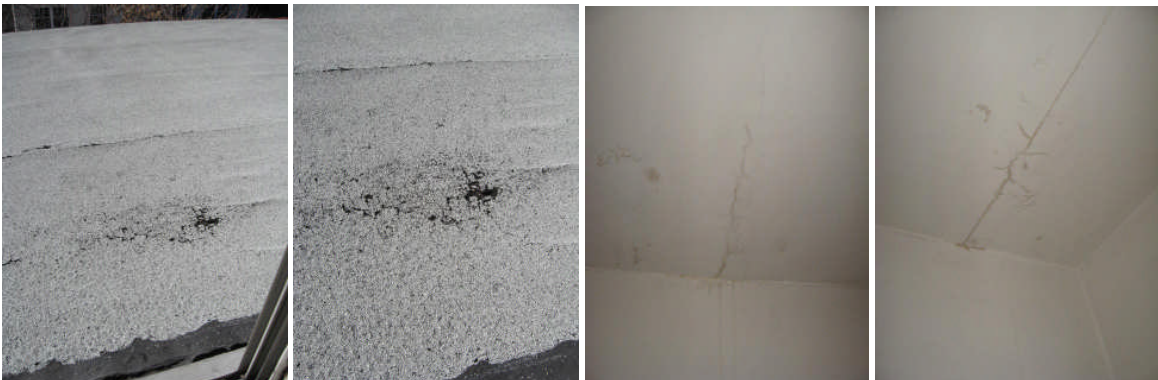
- Improve:** The roofing on the rear flat roof is nearing the end of its life cycle. Repairs to the roofing are recommended on the rear flat roof. Damaged or missing roofing material should be repaired. All roof penetrations should be examined and sealed as necessary.
- Improve:** Evidence of roof leakage was observed. Please refer to the Roofing section of the report for improvement recommendations.

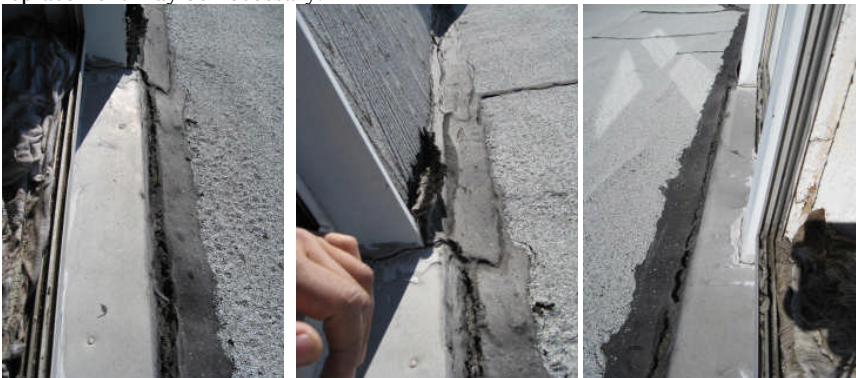
- **Improve:** Holes were observed in the flashing in many locations. Patching should be attempted. If this is unsuccessful, replacement may be necessary.

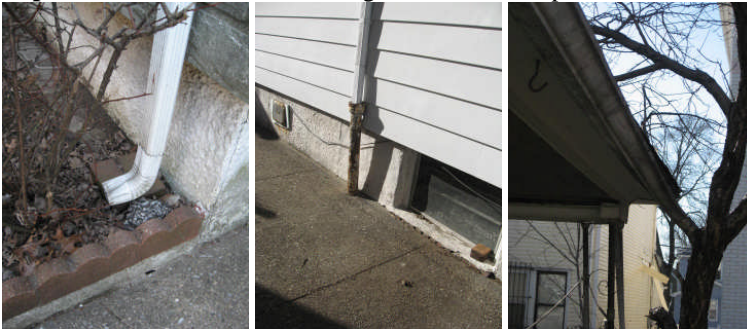
- **Improve:** The downspout(s) should discharge water at least five (5) feet from the house. Storm water should be encouraged to flow away from the building at the point of discharge.
- **Monitor:** The downspouts that discharge below grade level should be monitored. If they are ever suspected to be clogged or disconnected below grade, they should be redirected to discharge at least five (5) feet from the building. Foundation leakage adjacent to a downspout is an indication of a problem below grade.
- **Improve:** Missing or damaged downspouts on the garage should be repaired promptly.
- **Improve:** It is recommended that gutters and downspouts be installed on the left side of the garage.

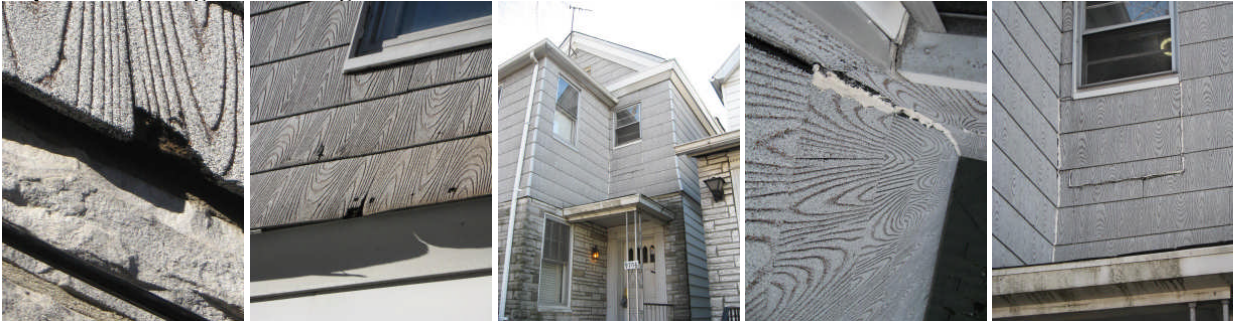
- **Improve:** Damaged siding in various locations should be repaired or replaced as needed.
- **Improve:** Openings in the siding at the front wall should be caulked and sealed.

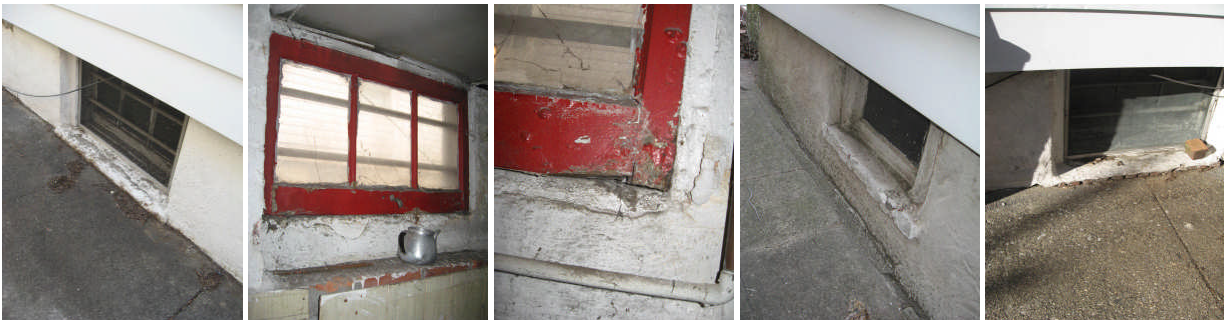
- **Improve:** The window in many locations shows evidence of substantial rot to the window frame. Repair to the window frame can usually be accomplished by a skilled carpenter, although a replacement window is preferred in some cases.
- **Improve:** As is very typical, the basement windows have been neglected. They should be repaired or replaced as desired. Wood/soil contact should be avoided.

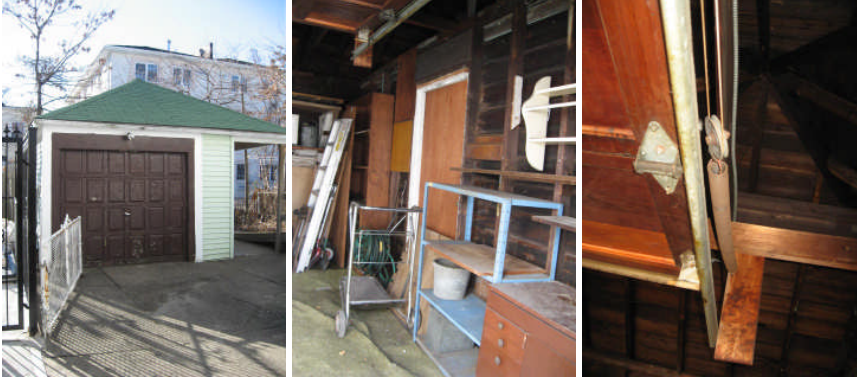
- **Monitor:** As is common in older neighborhoods, the detached garage is a low quality structure. With the exception of keeping the roof watertight and having functional gutters for roof water, rebuilding would eventually be needed which would be the better long-term approach.
- **Improve:** The door and doorjamb and/or trim side show evidence of localized rot. Repairs should be undertaken as necessary.
- **Improve:** No safety springs/cables were noted on the garage door springs. The installation of the springs/cables would improve safety during operation.

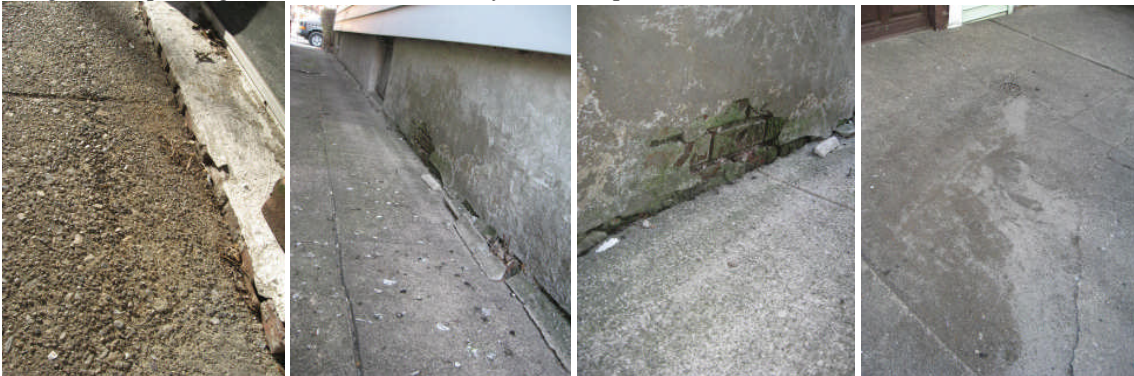
- **Improve:** The driveway and walkway around the house should be sealed where it meets the house throughout.
- **Monitor:** The driveway drain at the rear of the property is considered marginally adequate. Its performance should be carefully monitored during heavy rains. Care should be taken to maintain this drain free of debris. If problems develop, a large drain spanning the width of the driveway would be preferred.

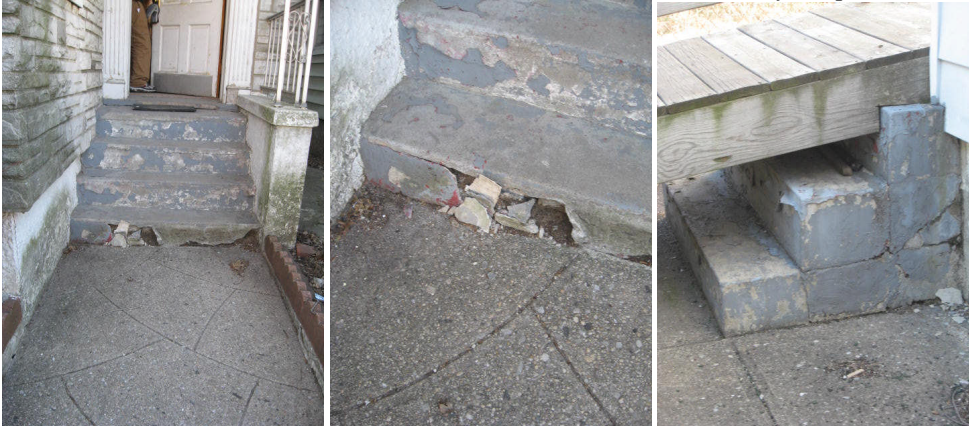
- **Improve:** The steps at the front of the property have deteriorated noticeably. Repairs are recommended.
- **Improve:** The steps at the rear of the property have deteriorated noticeably. Repairs are recommended.

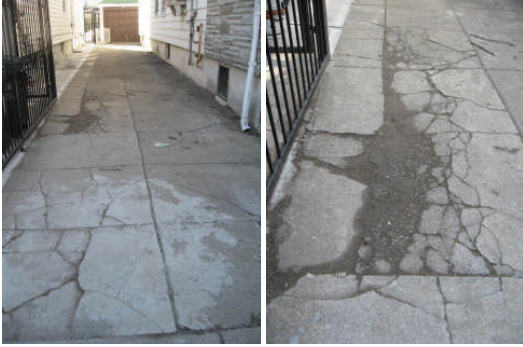
- **Safety Issue:** The driveway presents a trip hazard. This condition should be altered for improved safety.

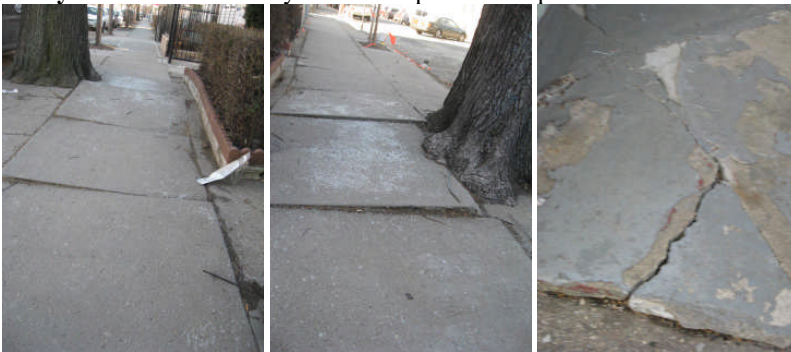
- **Safety Issue:** The walkway / sidewalk present a trip hazard. This condition should be altered for improved safety.

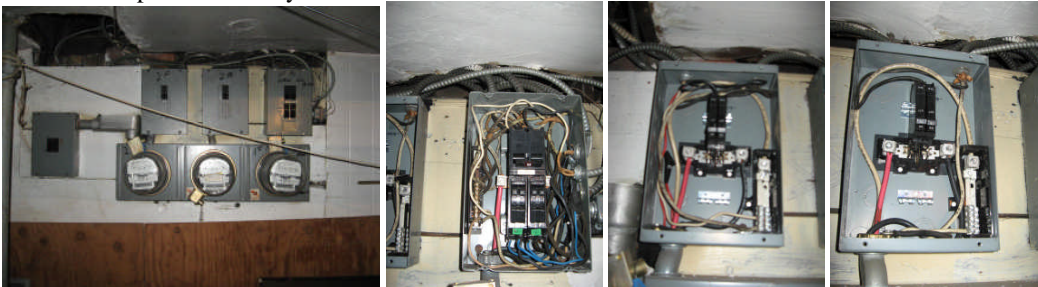
- **Improve:** The main distribution panel for the first floor does not contain enough circuits to properly serve the home. A larger panel or an auxiliary would be desirable.
- **Improve:** Circuits within the main distribution panel for the first floor that are doubled up (referred to as “double taps”) should be separated. Each circuit should be served by a separate fuse or breaker.
- **Improve:** The numbers of circuits within this home are considered less than ideal. If fuses blow (or breakers trip) regularly, this may indicate the need for additional circuits. It does not indicate that your electrical service is undersized, nor does it represent a safety concern. Circuits can be added on an as needed basis.

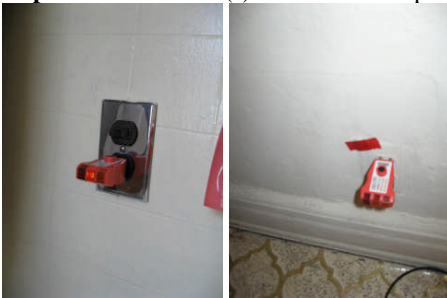
- **Improve:** The outlet(s) that have been painted over in various locations should be improved.

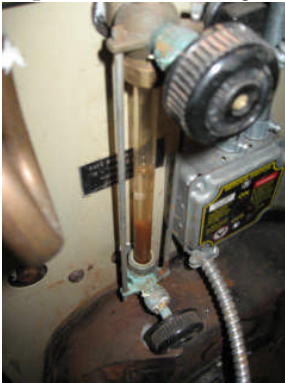
- **Improve:** The boiler requires servicing by a qualified HVAC technician.
- **Improve:** Leak at the glass gauge should be repairs

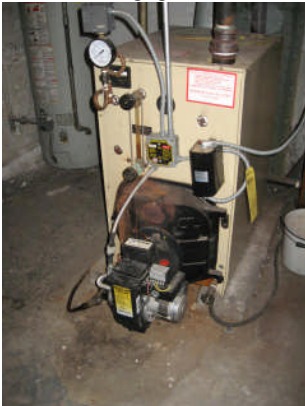
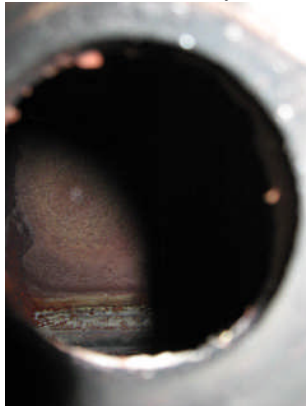
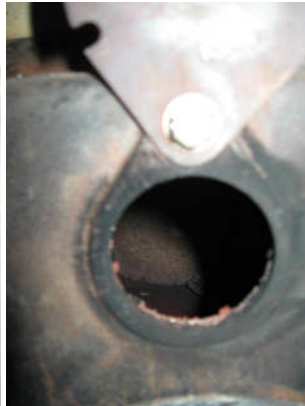
- **Improve:** Soot builds up and/or rust debris was observed in the flame chamber. A qualified licensed heating technician should be engaged to clean service and re-test the system.

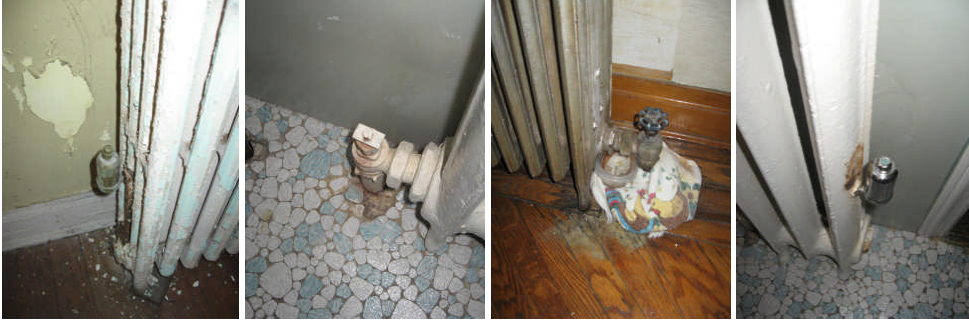
- **Improve:** Damaged and leaking radiator air pressure valve, shut off valve and handles should be replaced.

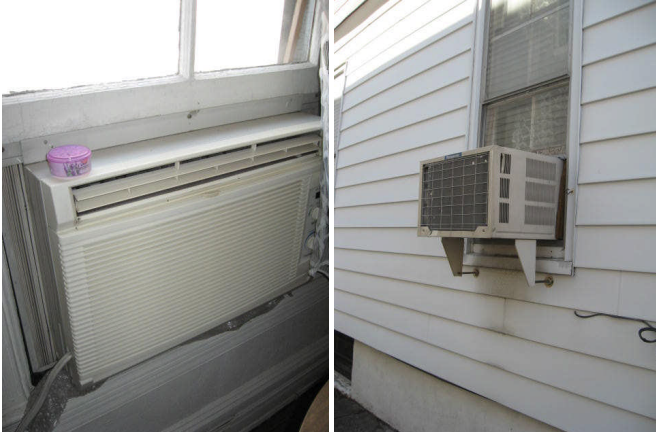
- **Improve:** The first floor is been cooled by window air conditioning unit in the hot summer days.

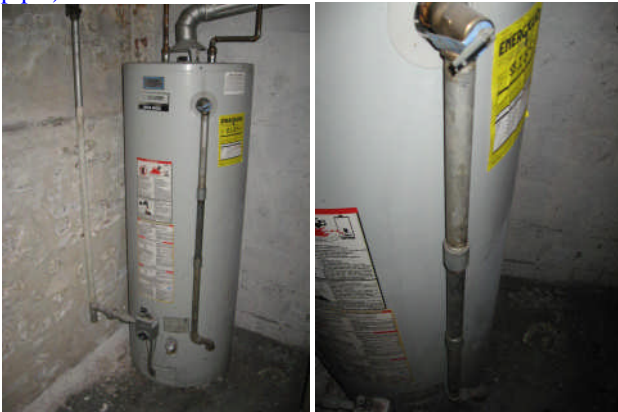
- **Monitor:** Water heaters have a typical life expectancy of 7 to 12 years. The existing unit is approaching this age range. One cannot predict with certainty when replacement will become necessary.
- **Improve:** The discharge piping serving the Temperature and Pressure Relief (TPR) Valve for the water heater should terminate not less than 6 inches or more than 8 inches above the floor. ([Remove the fitting at the end of the discharge pipe.](#))

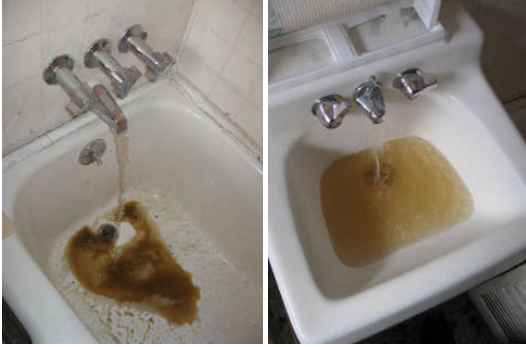
- **Monitor:** The older steel piping in many locations is subject to corrosion on the interior of the pipe. As corrosion builds up, the inside diameter of the pipe becomes constricted, resulting in a loss of water pressure. This piping is typically replaced when the loss of pressure can no longer be tolerated.
- **Improve:** The installation of shut-off valves is recommended at the water supply lines under the sinks throughout where they are missing.

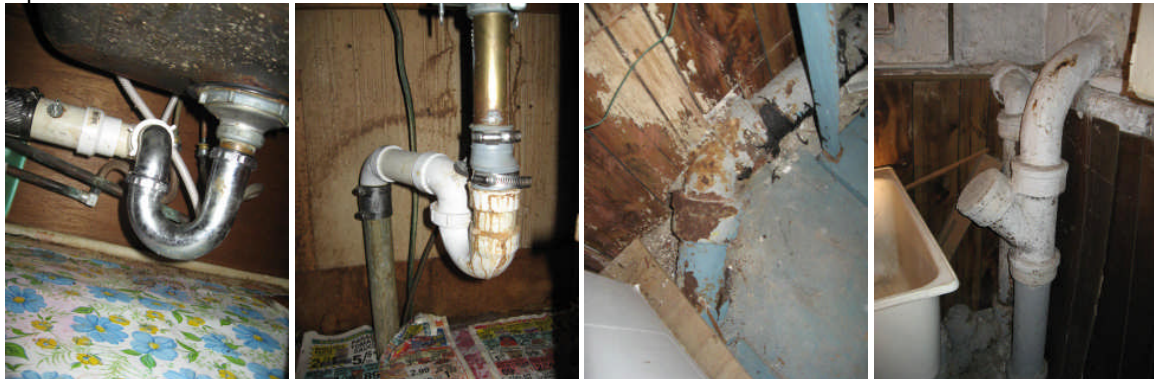
- **Monitor:** An “S” trap has been used in many locations. Ideally, S traps should be replaced as they are subject to siphoning problems. S traps are common in older homes. Replacement is sometimes difficult and thus the S traps are usually tolerated. Care should be taken to keep the trap “primed”. Fixtures should be monitored for sewer odor.
- **Monitor:** For the most part, the waste piping is older throughout. It may be prone to unexpected problems. Improvement is recommended on an as needed basis.

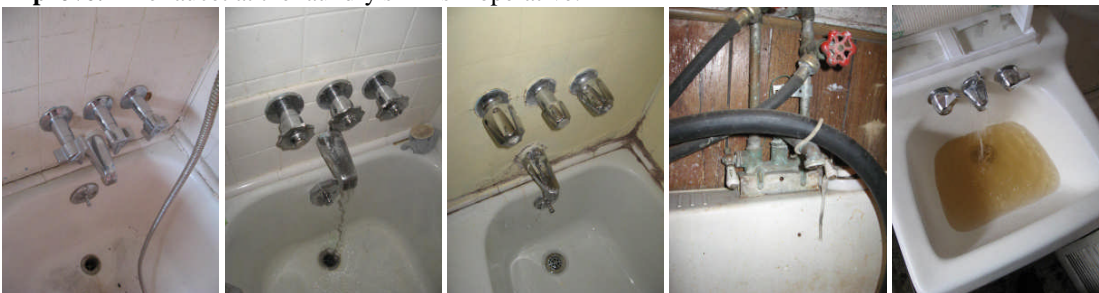
- **Monitor:** The majority of plumbing fixtures throughout are older.
- **Monitor:** The faucets throughout are showing signs of age. Updating faucets over time should be anticipated.
- **Improve:** The faucet in the second floor front bathroom is inoperative.
- **Improve:** The sink in the second floor bathroom was observed to drain slowly, suggesting that an obstruction may exist.
- **Improve:** The faucet at the laundry sink is inoperative.

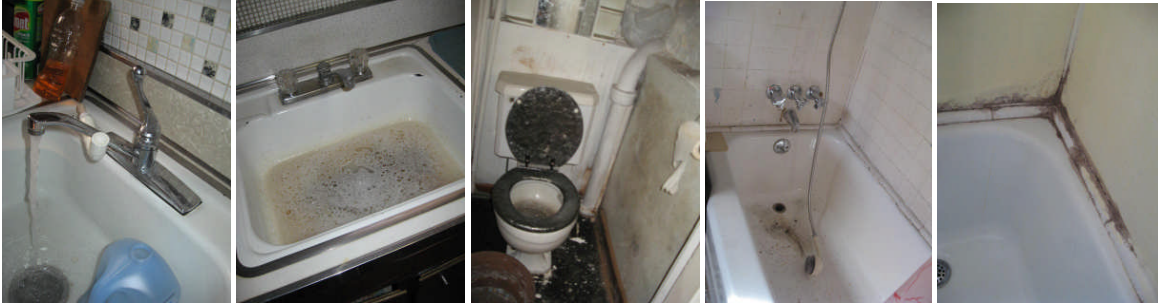
- **Improve:** The bathtubs enclosure throughout should be rebuilt. Wall damage behind the enclosure should also be repaired.

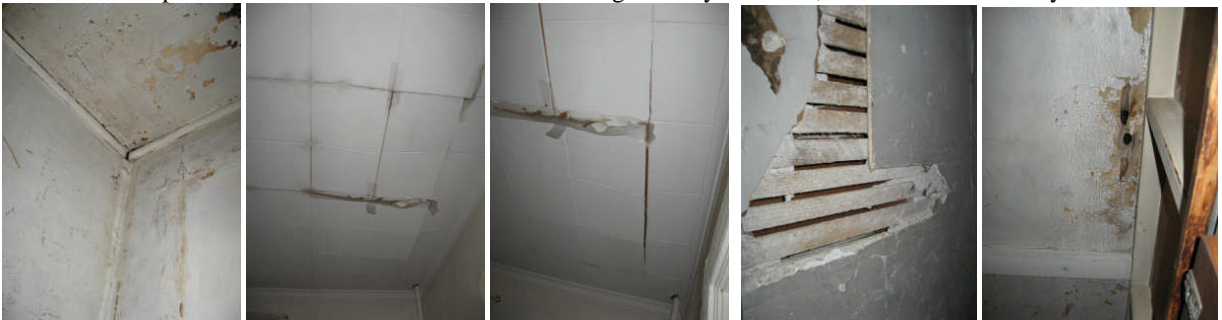
- **Monitor:** Water staining was noted in various locations on the second floor and in the attic.
- **Improve:** Larger than typical cracks were noted in many locations.
- **Monitor:** Loose or weakened finishes were detected in many locations.
- **Monitor:** The plaster shows evidence of bulging in many locations. Repairs may be desirable.
- **Monitor:** The plaster finishes show evidence of weakening in many locations, as is common in many older homes.

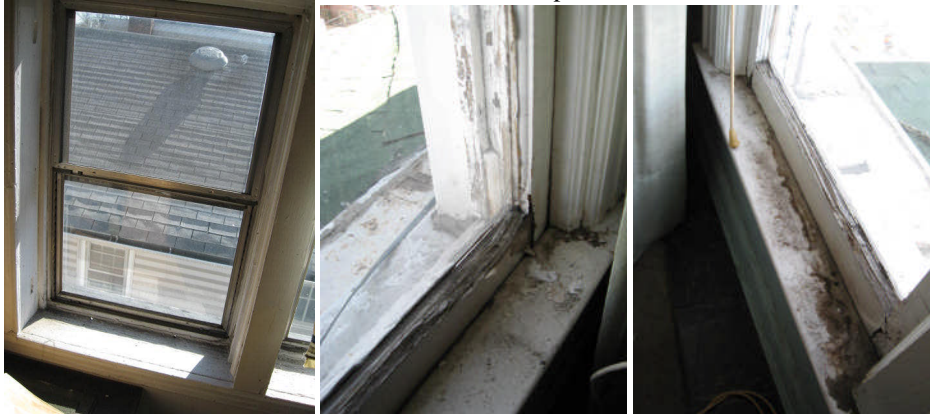
- **Improve:** The window(s) will not lock in various locations.
- **Monitor:** Damaged screens were noted on windows in various locations.
- **Improve:** Water damage was observed below the window sill(s) in various locations. This would suggest chronic leakage. Caulking can be improved as a first step. If leakage persists, replacement of the window and repair to any concealed damage may be necessary. Refer also to the Exterior section of this report.

- **Monitor:** Water staining was observed below the window sill(s) in various locations. Caulking should be improved as a first step. Refer also to the Exterior section of this report.

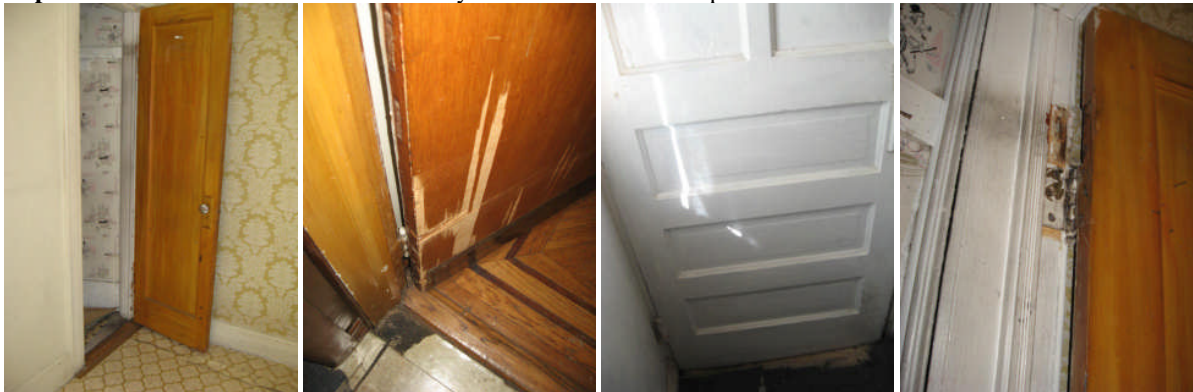
- **Improve:** The door in many locations does not close/latch properly these doors should be trimmed or adjusted as necessary to work properly.
- **Improve:** Weather-stripping improvements are needed at the exterior doors.
- **Improve:** Damaged or non-functional door hardware in many locations should be improved.
- **Improve:** The loose door hardware in many locations should be improved.

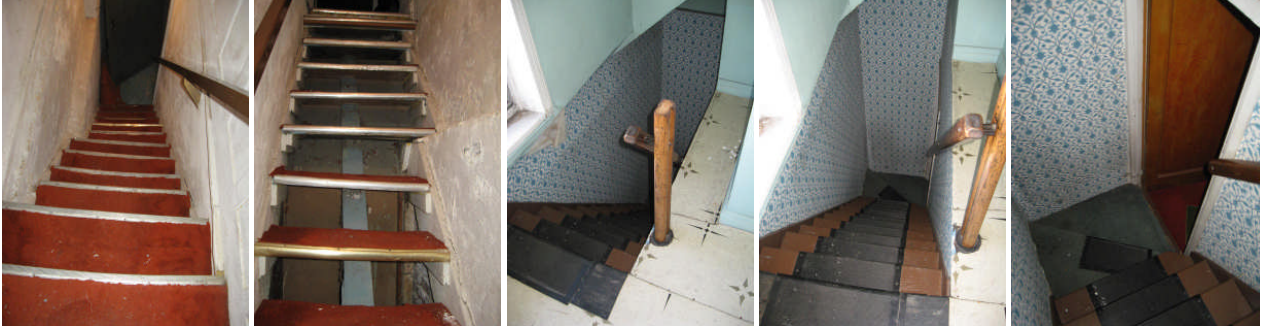
- **Improve:** The basement stairs shows evidence of substantial rot to the riser. A skilled carpenter can usually accomplish repair to the riser, although a replacement is preferred and recommended.
- **Safety Issue:** For improved safety, it is recommended that a railing be provided for the in the attic stairway.
- **Monitor:** The in the attic stairway is relatively steep. It may not be practical to change this condition. Extreme care should be taken when using this stairway. *Carelessness could lead to an accident.*

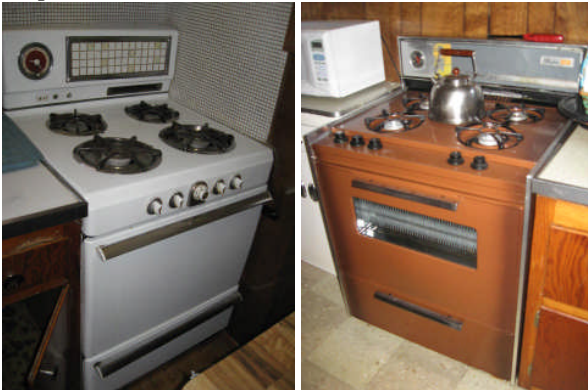
- **Monitor:** The gas ranges are older units and consider being unsafe. *Replacement is recommended immediately for improved safety.*
- **Improve:** The new ranges should be equipped with an anti-tip device. This device helps in preventing the range from tipping forward if a heavy load is placed on the door when it is opened.

- Note: These gas ranges was not tested due to safety concern.
